Project Description/Narrative

AIA Rochester Community Impact Award

AIA ROCHESTER 2023 DESIGN AWARDS
24 JONES AVENUE
REHABILITATION HOME
Rochester, NY

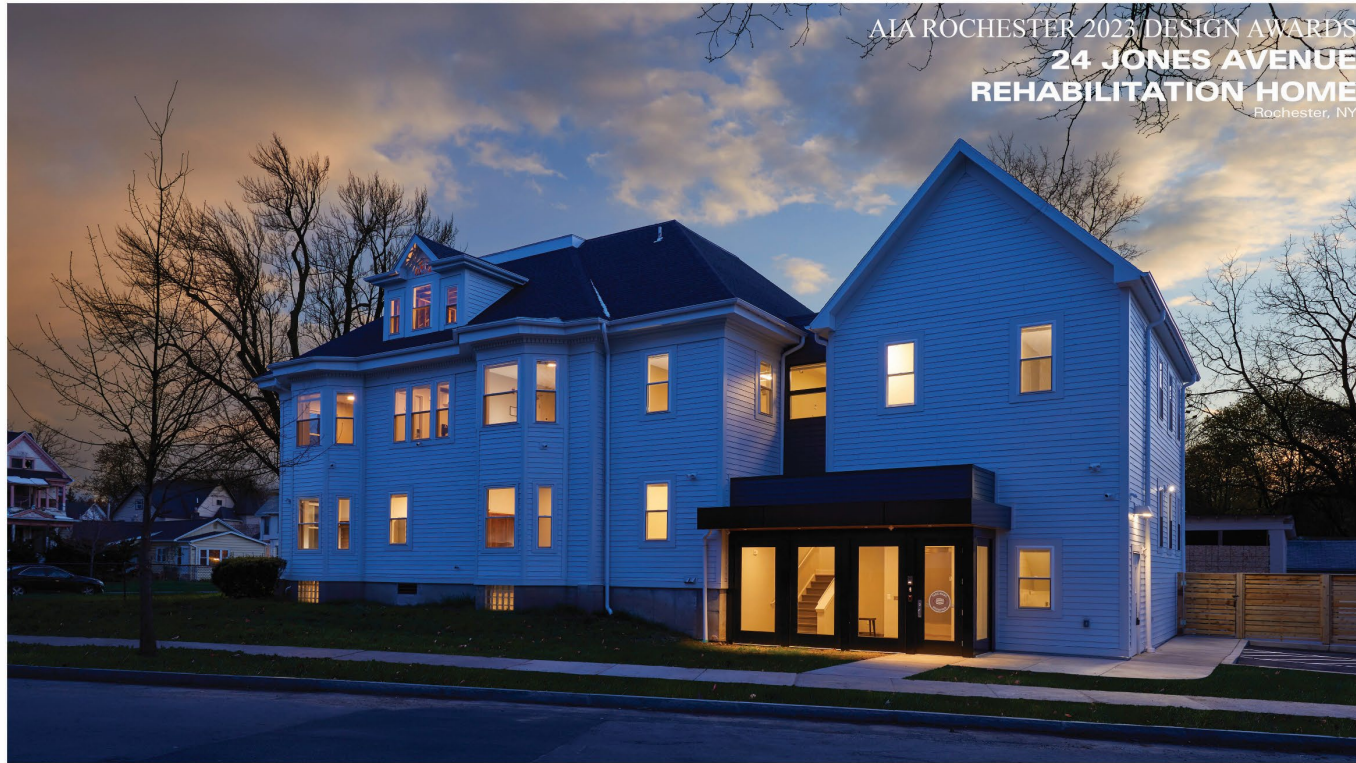
This collage includes: a small exterior photo of the original house; interior photos of a kitchen, a living room with a fireplace, and a staircase; a large exterior photo of the new entrance canopy; three architectural floor plans (Second, First, and Basement) with a legend and scale; a daytime exterior photo of the house; and an aerial view of the neighborhood.

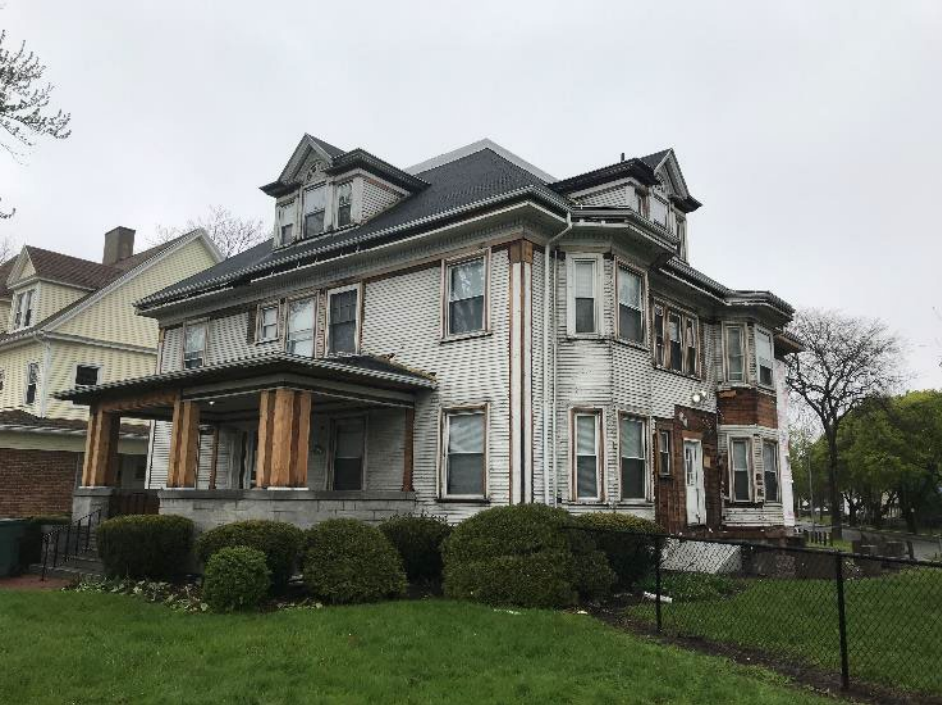
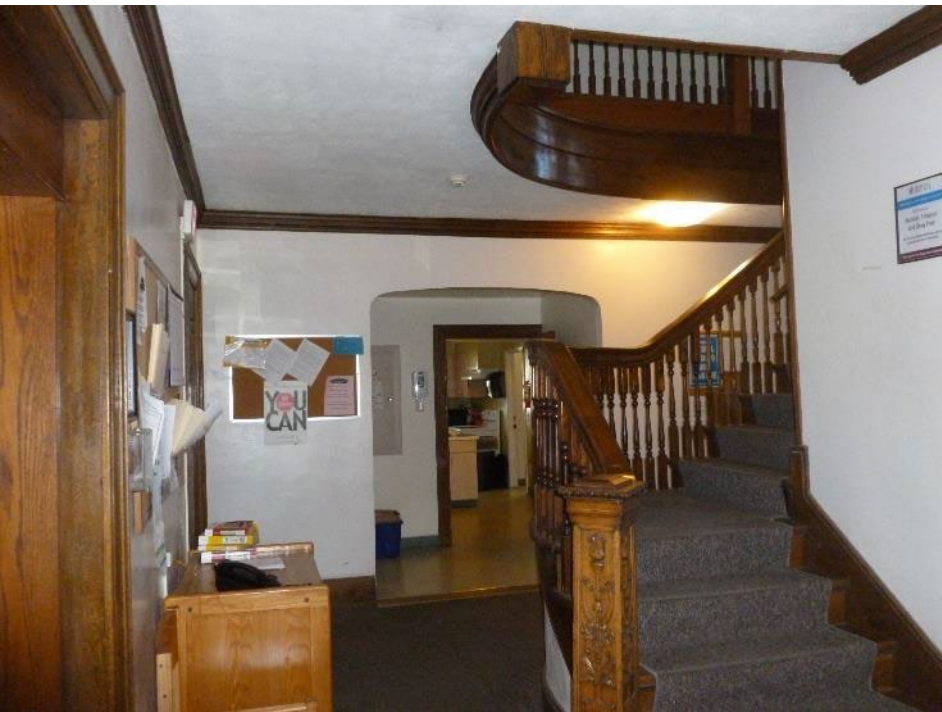
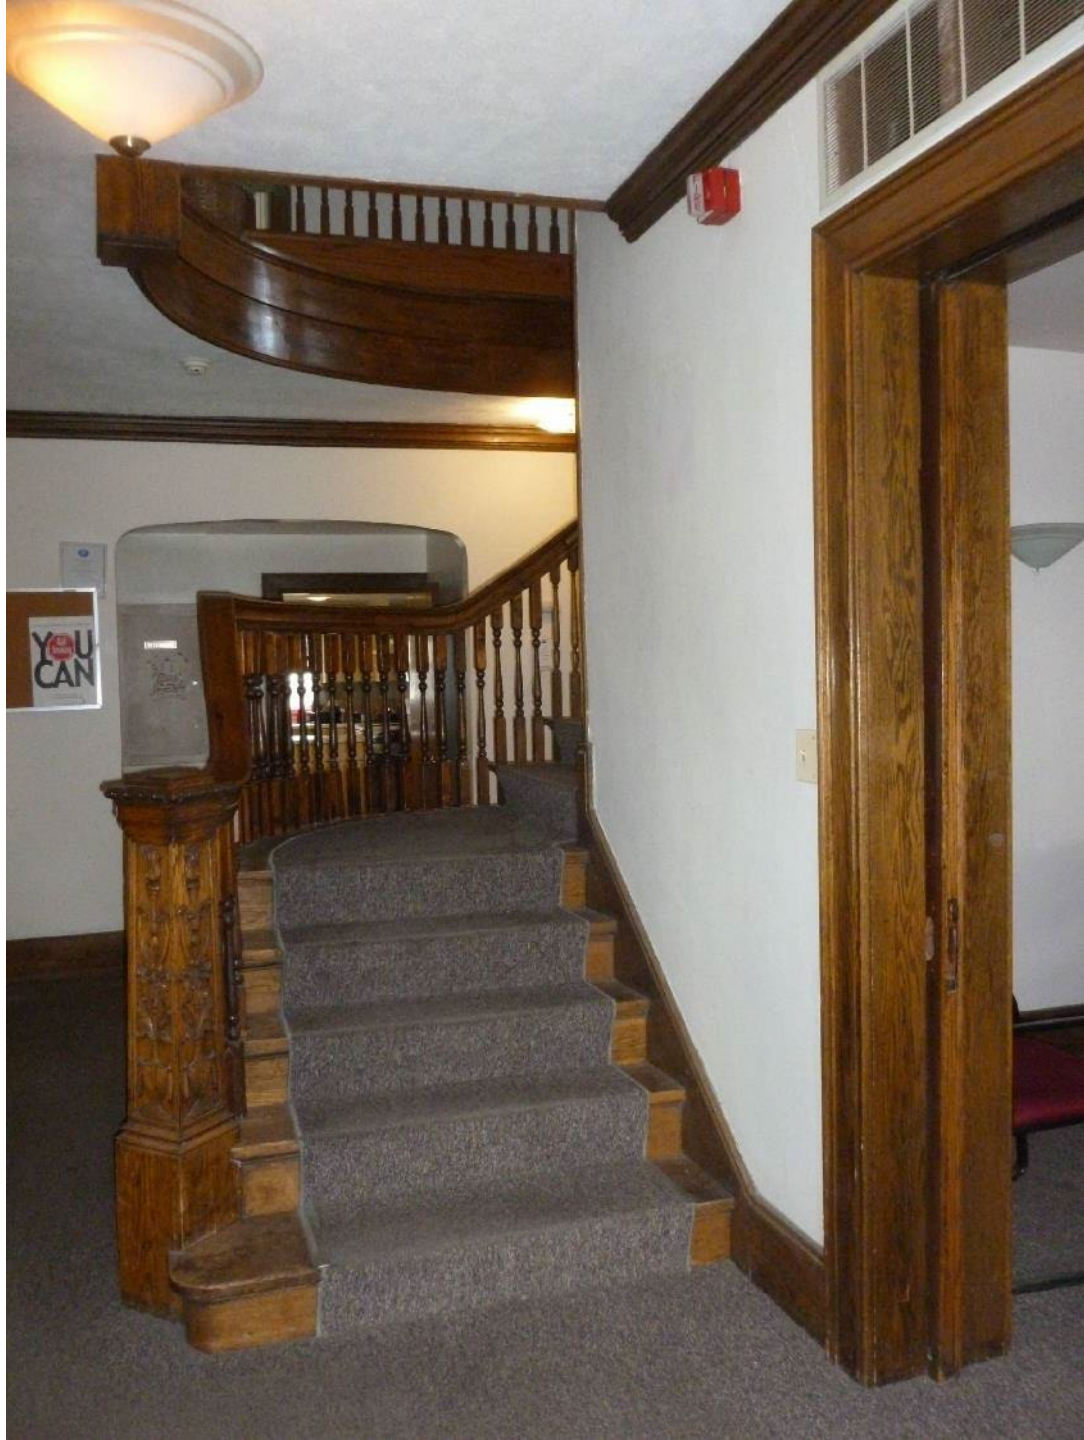
Photos Prior to Renovations

(Top Left)
View of exterior looking
Northwest

(Bottom Left)
View of entrance Hall / Lobby
looking north

(Right)
View of communicating stair in
entrance Hall / Lobby

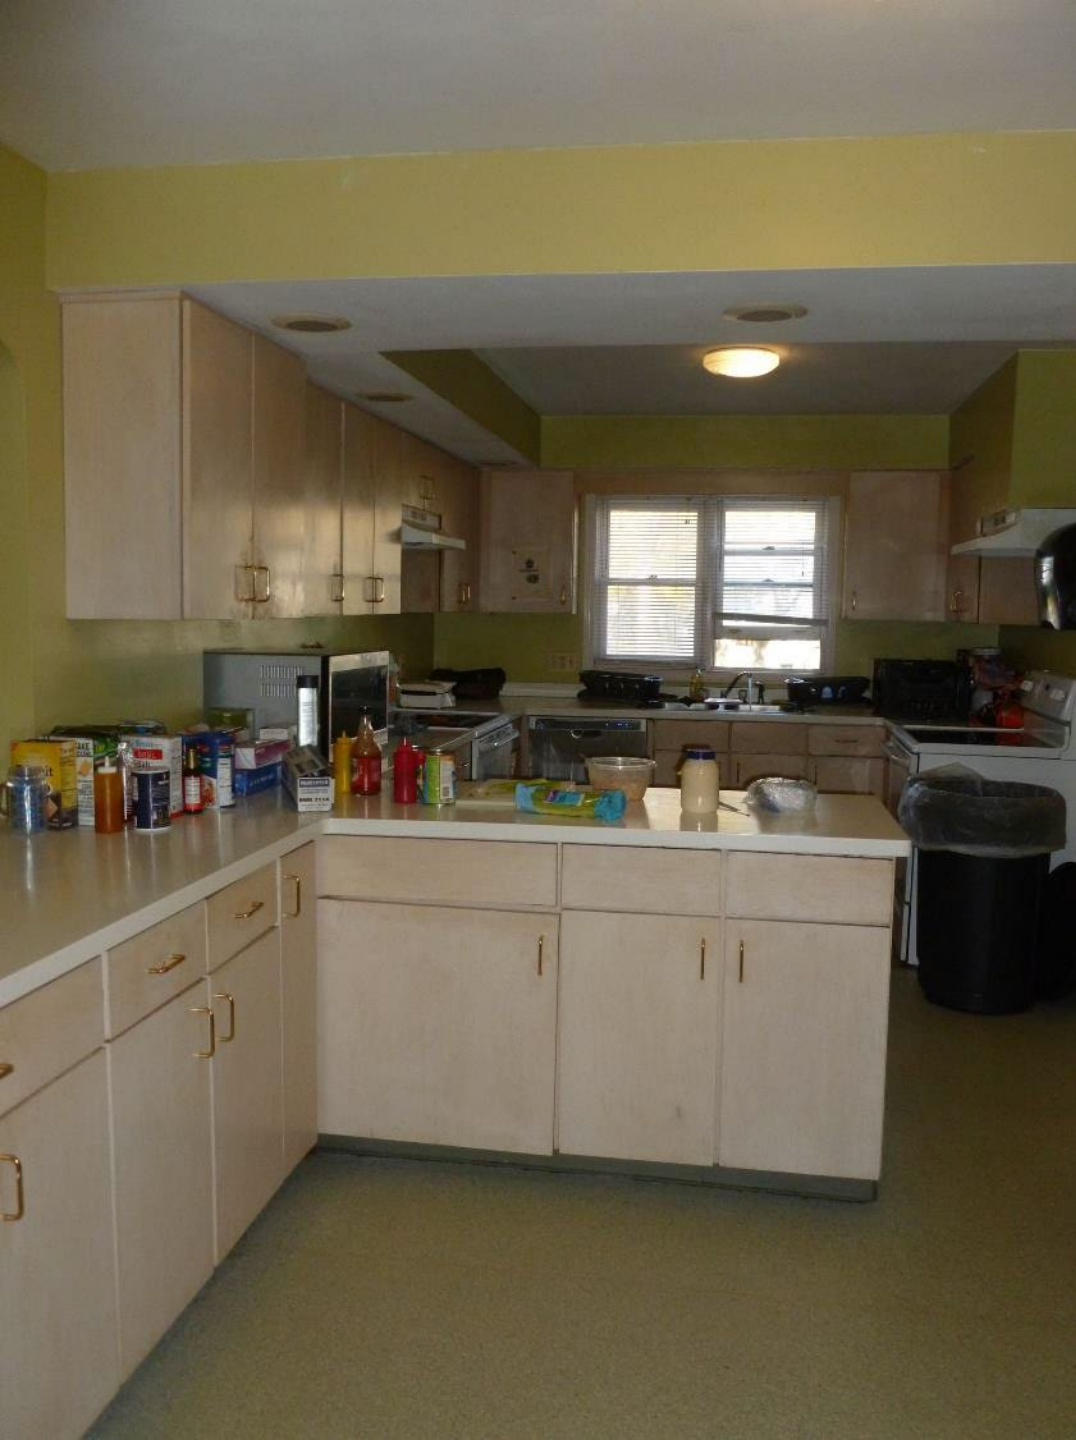
(Left)
View of existing kitchen (This was removed to accommodate central circulation hallway)

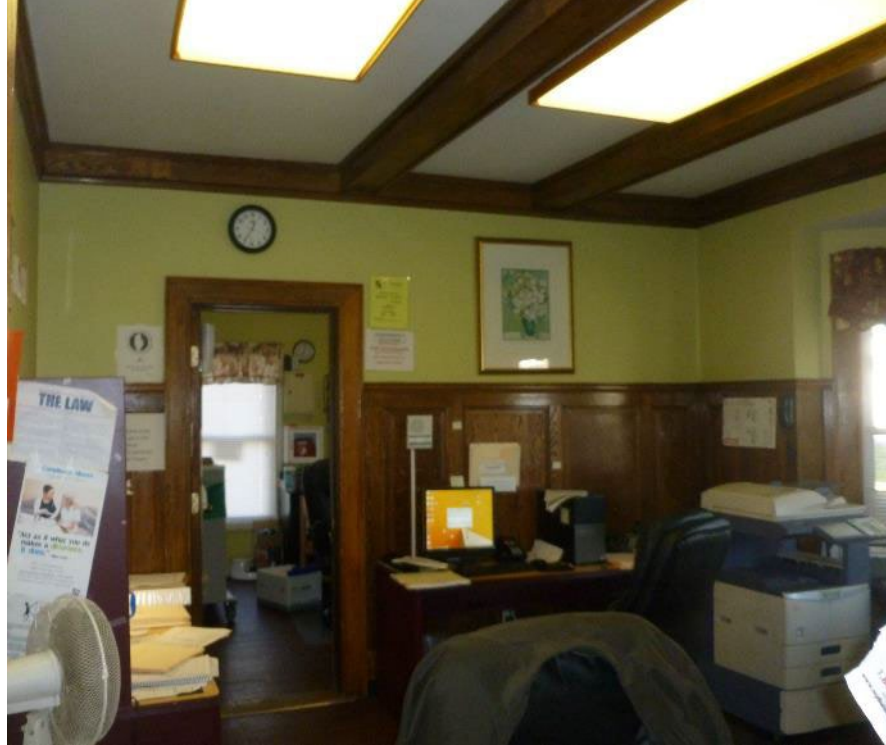
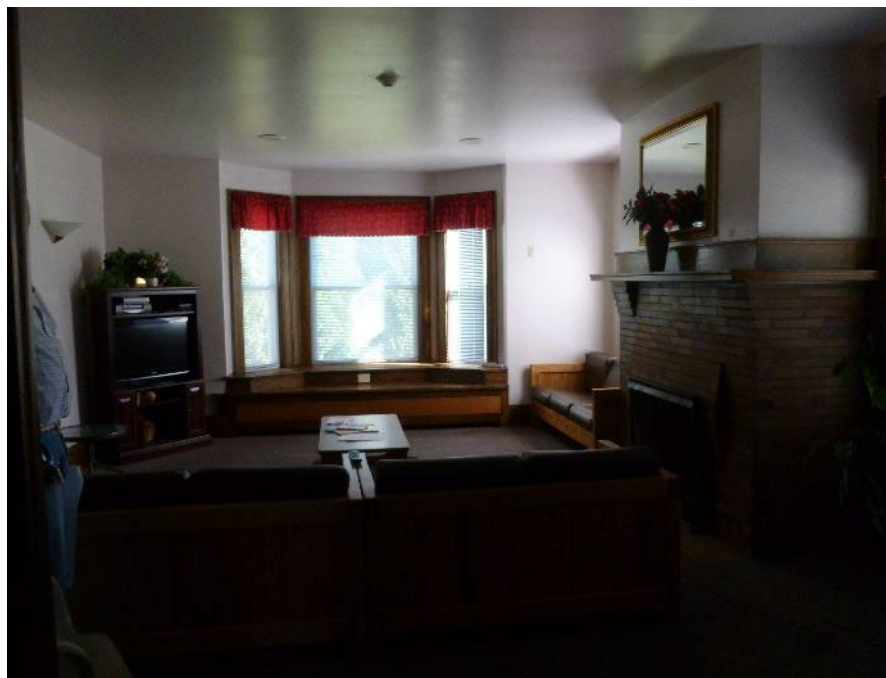
Photos Prior to Renovations

(Top Right)
View of staff office looking north

(Bottom Right)
View of Living Room

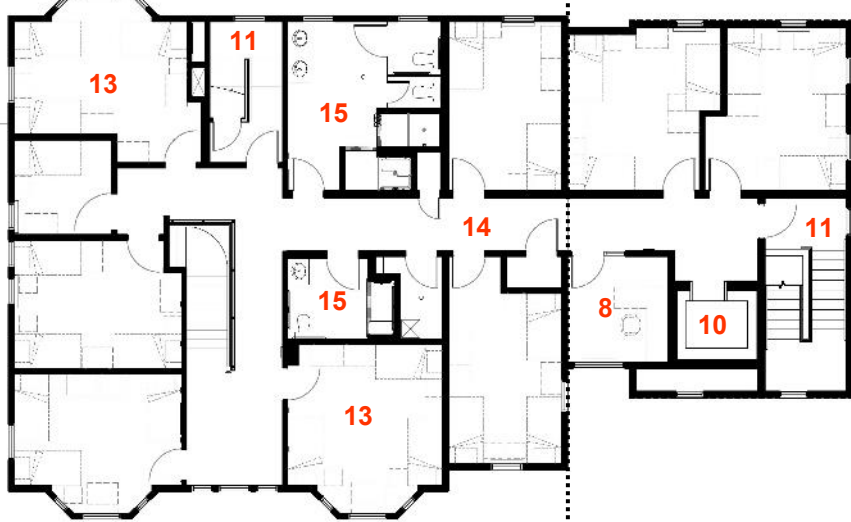
SECOND FLOOR PLAN

| 1. FRONT PORCH | 8. OFFICE | 16. RECREATION ROOM |
| 2. FOYER | 9. TOILET ROOM | 17. EXERCISE ROOM |
| 3. LIVING ROOM | 10. ELEVATOR | 18. MECHANICAL |
| 4. STUDY | 11. STAIR | 19. UTILITY ROOM |
| 5. MED ROOM | 12. ENTRANCE LOBBY | 20. PANTRY |
| 6. KITCHEN | 13. SLEEPING ROOM | 21. LAUNDRY |
| 7. DINING ROOM | 14. CORRIDOR | 22. INTAKE ROOM |
| | 15. BATHROOM | |

RENOVATION ←-----→ ADDITION

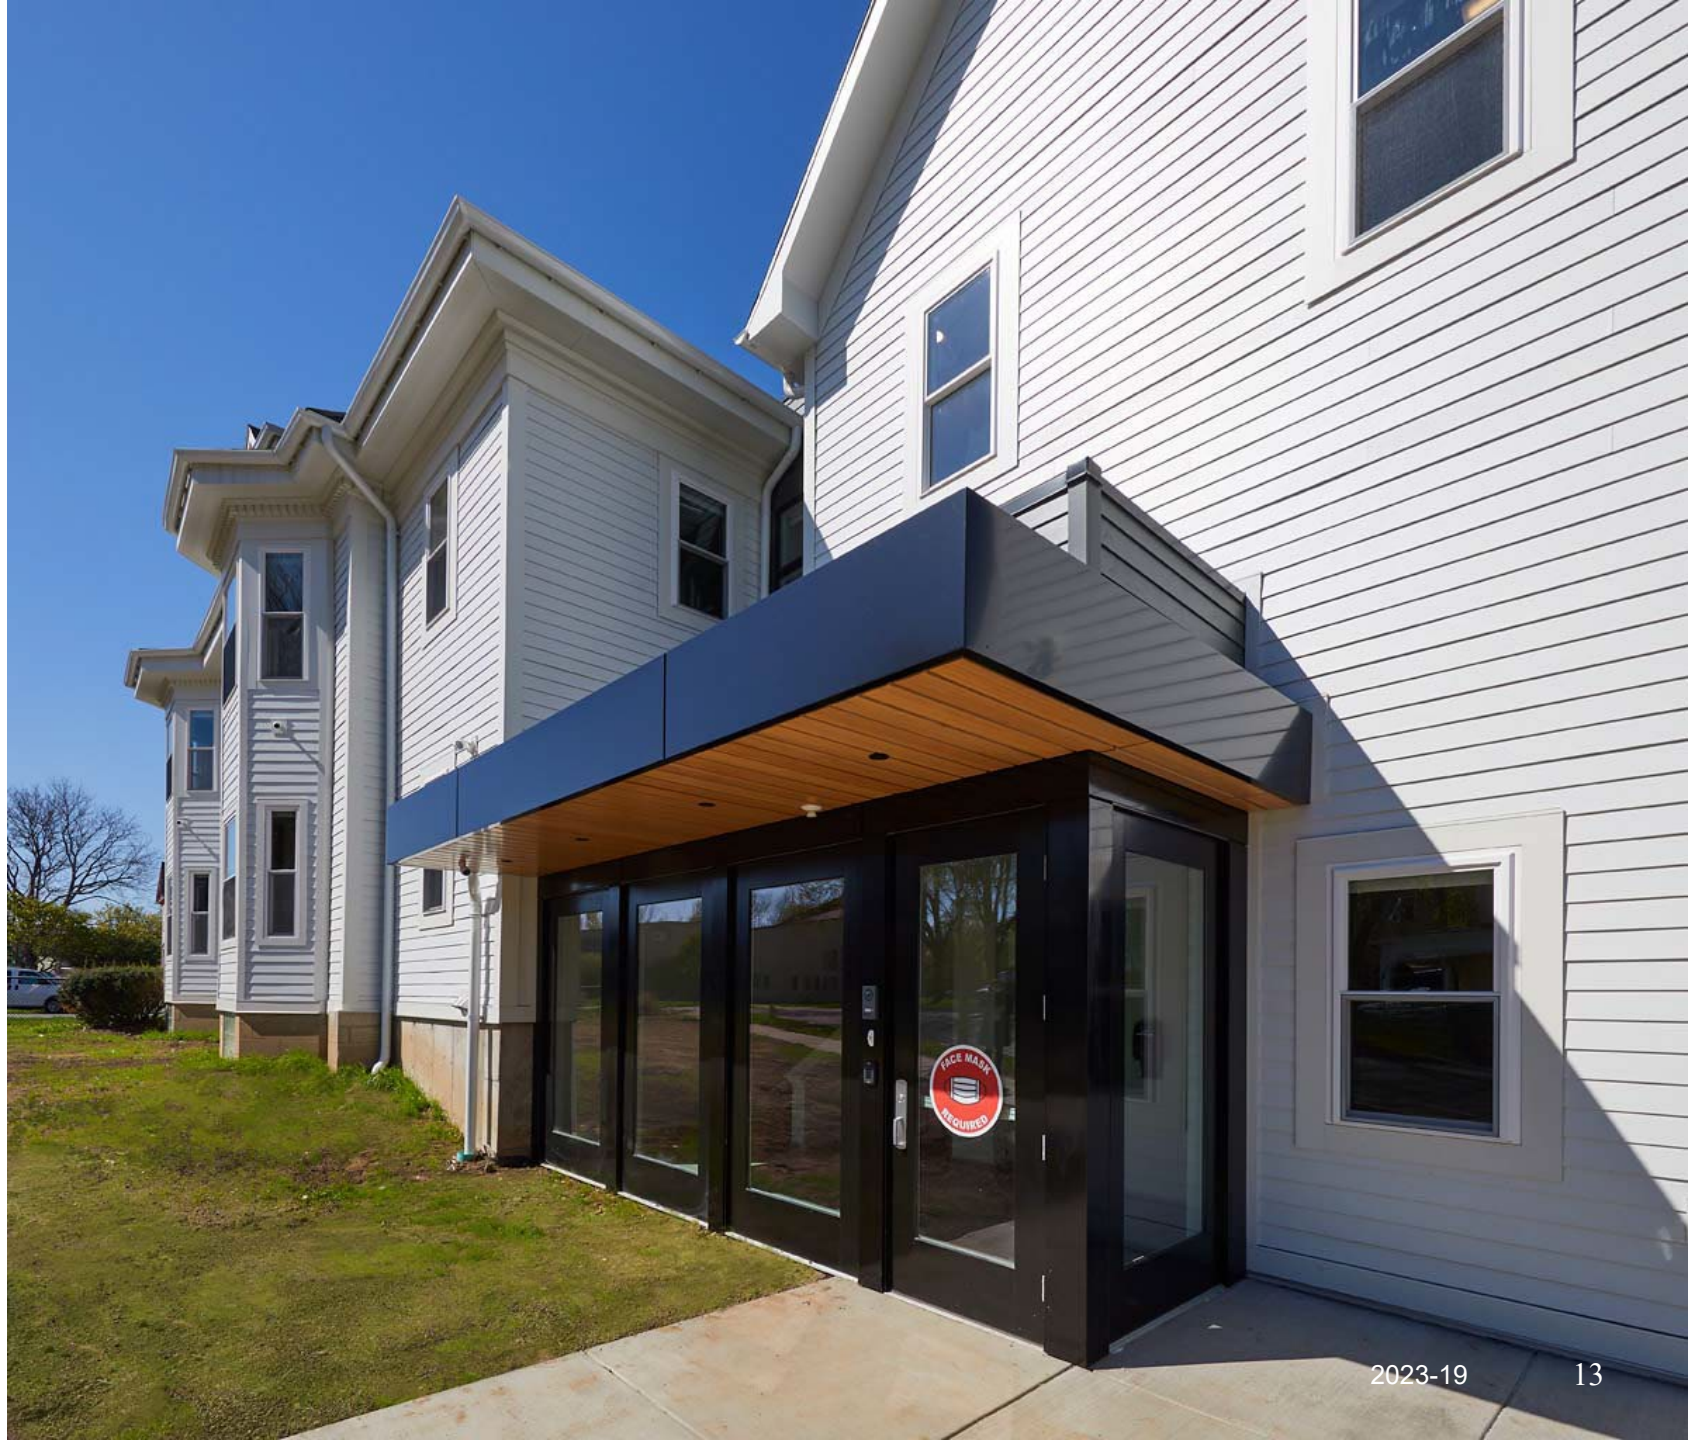
“A transparent glazed entrance lobby and new electric traction elevator were added, strategically separated from the original house with a recessed connector link.”

To provide accessibility to the entire residence, a modest addition takes cues from a home that once stood on that portion of the site, with a simple gable roof, horizontal lap siding, and punched double hung windows. A transparent glazed entrance lobby and new electric traction elevator were added, strategically separated from the original house with a recessed connector link.
